Delsea Home Inspection

Property Inspection Report

123 Main Street, Anytown, NJ
Inspection prepared for: Sample Sample
Date of Inspection: 1/30/2016
Age of Home: 41 years old Size: 2000 sq/ft
Weather: clear/sunny 55 degrees

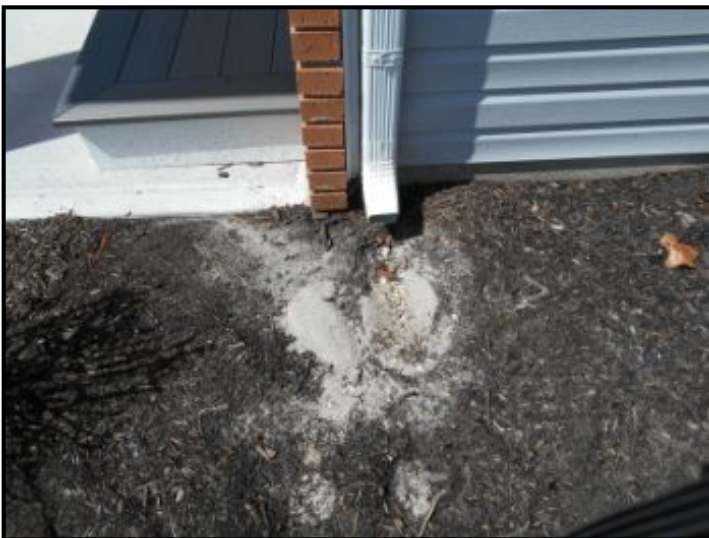
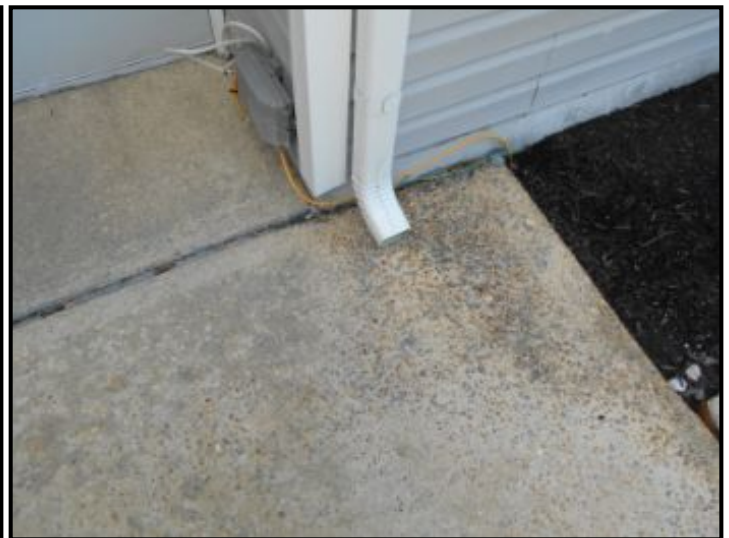
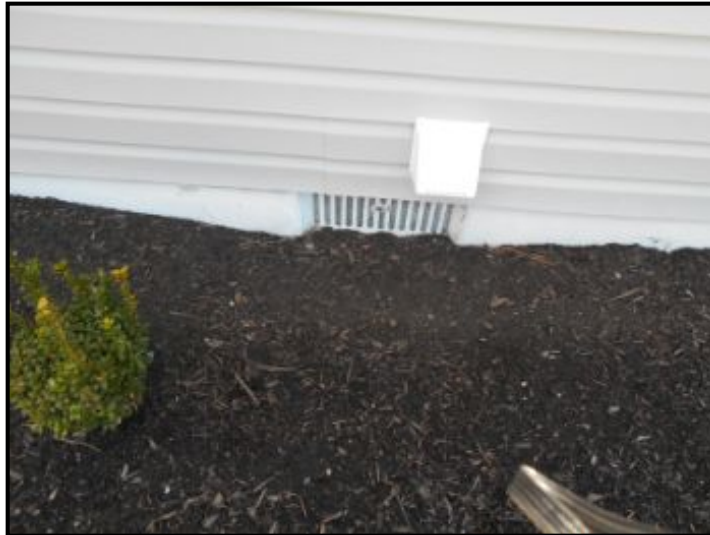
- **IMPROVE:** Recommend extending downspouts from exterior gutters. This is to improve proper drainage of water from foundation to prevent moisture intrusion.
- Siding to Soil contact or proximity. This may provide entrance of moisture or insects to siding. Recommend grading soil so there is at least 6" of space (where practical) between the siding and the soil below.

Siding to Soil contact or proximity. This may provide entrance of moisture or insects to siding. Recommend grading soil so there is at least 6" of space (where practical) between the siding and the soil below.

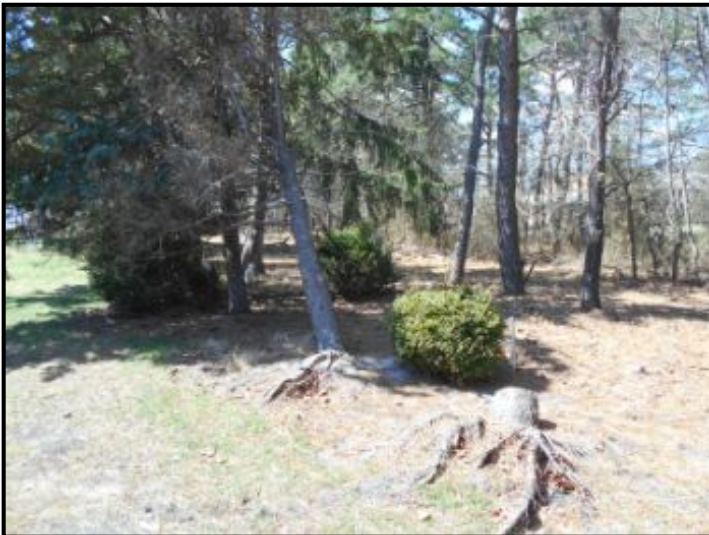
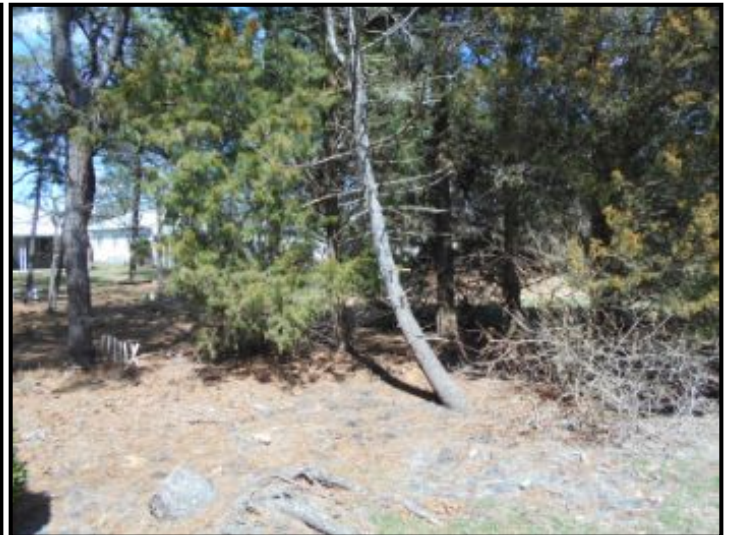
- Several dead trees were observed in the back yard near the property line. Recommend consulting a qualified Tree Service Professional to remove the tree. Failure to do so may result it falling on the dwelling.

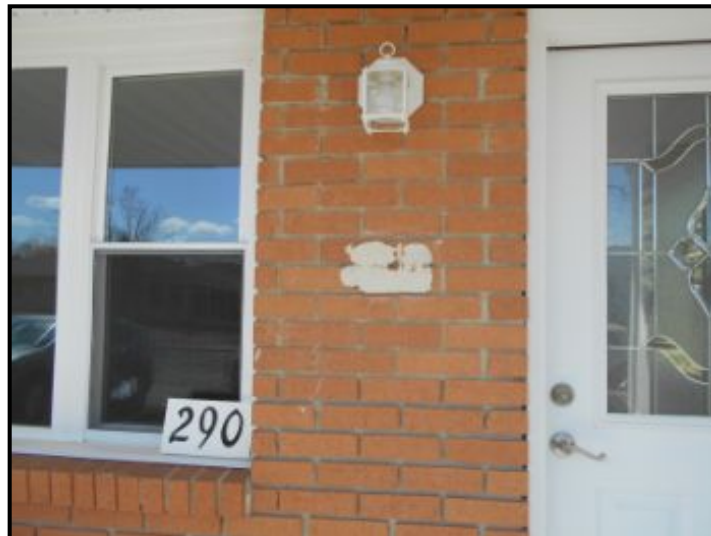
- Vinyl siding, Brick cladding, wood frame construction, concrete / block foundation
- House numbers not affixed to the brick cladding near the front door. Recommend servicing by a qualified contractor.

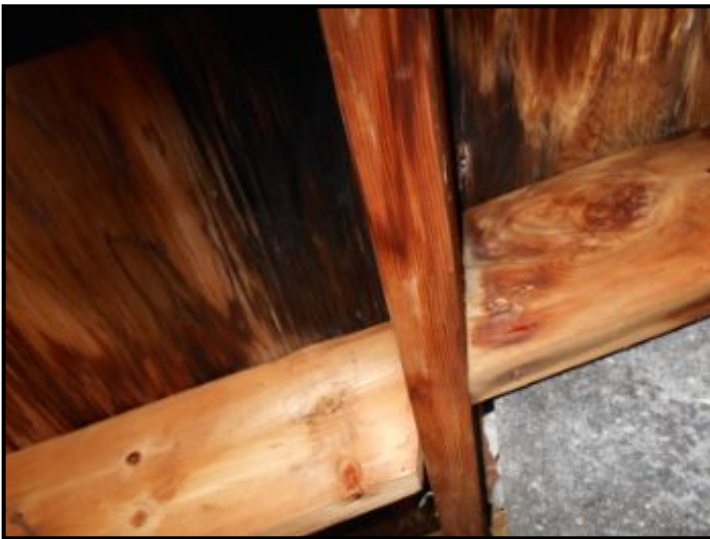
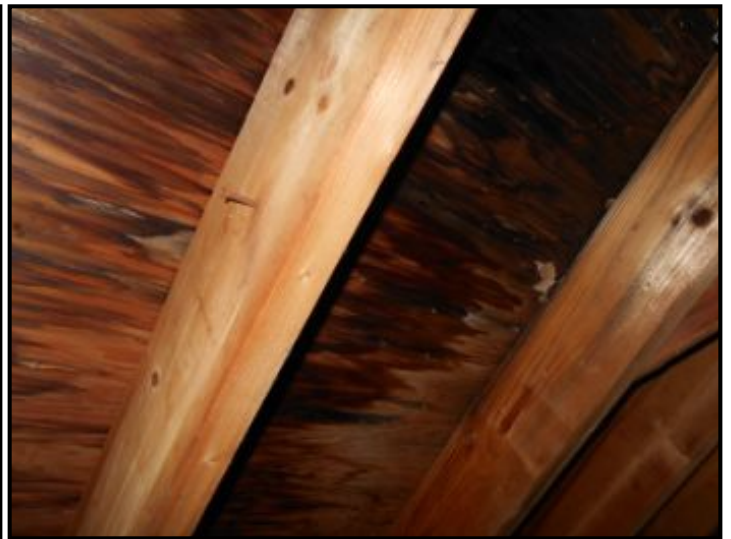
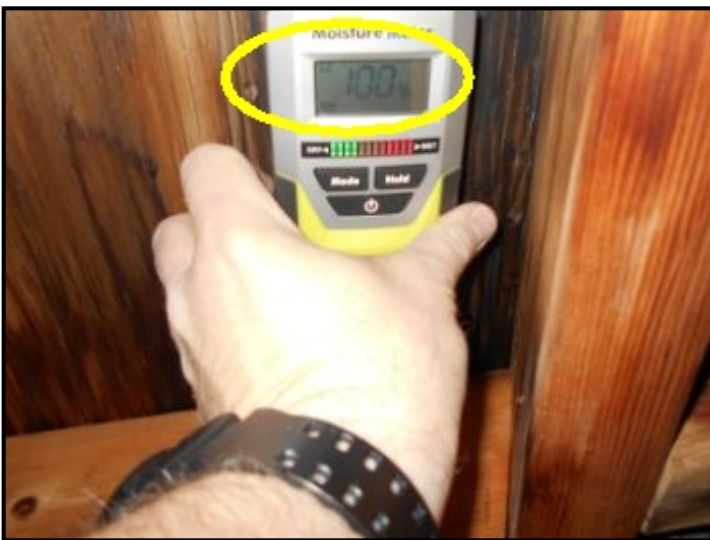
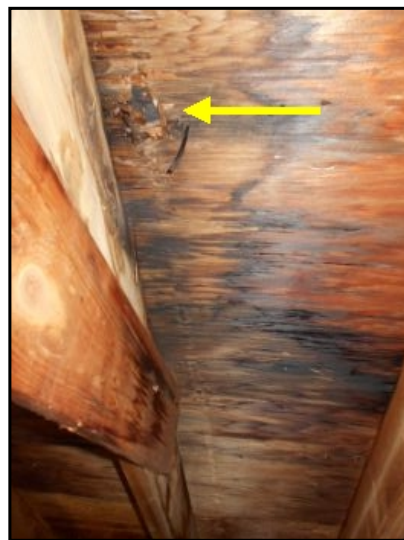
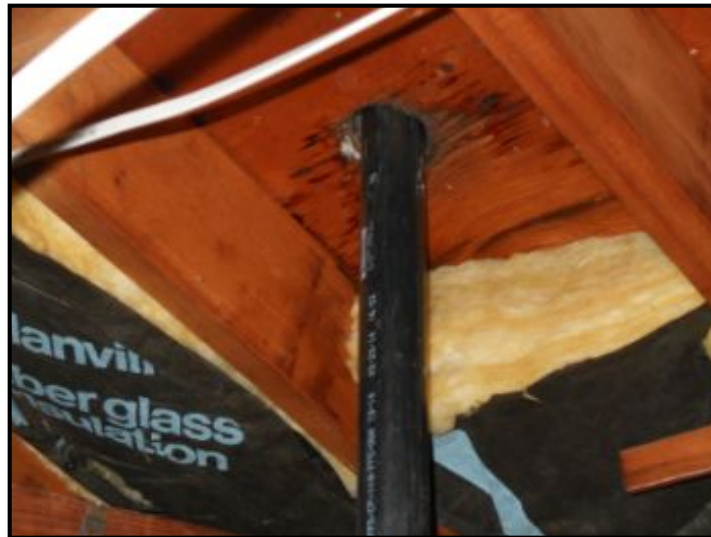
- Evidence of an organic substance consistent with mold was observed on the underside of the roof in the attic adjacent to the chimney.

In the attic, roof sheathing adjacent to the chimney is damaged by moisture intrusion. This is seen on all sides of the chimney. A moisture meter was utilized and obtained a reading of 100% which indicates an active scene. The plywood is brittle and damaged due to ongoing moisture intrusion. Recommend a licensed/qualified roofing contractor evaluate and repair prior to settlement.

Recommend testing and remediation by a qualified and licensed contractor prior to closing.

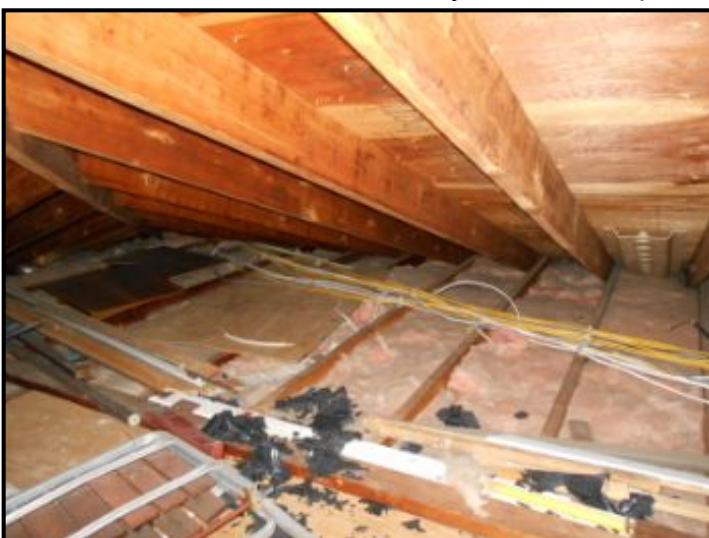
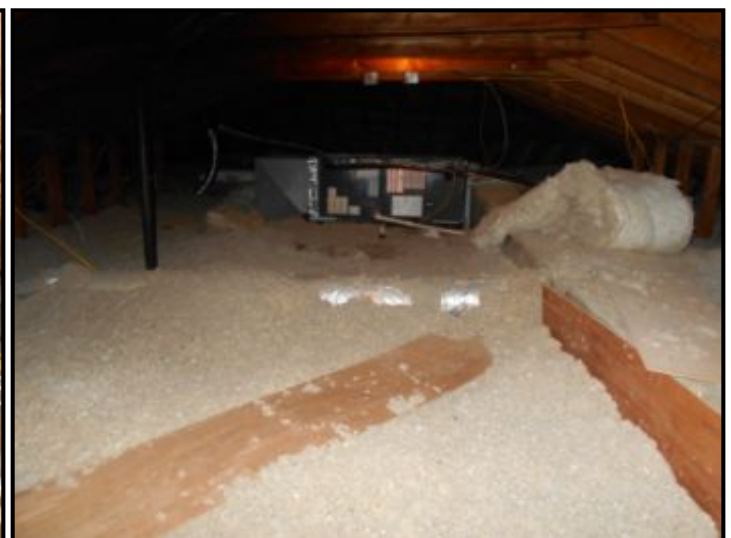
- Insulation is minimal in some areas and missing in others. Recommend installing an average of 13 inches of blown insulation by a licensed/qualified contractor.

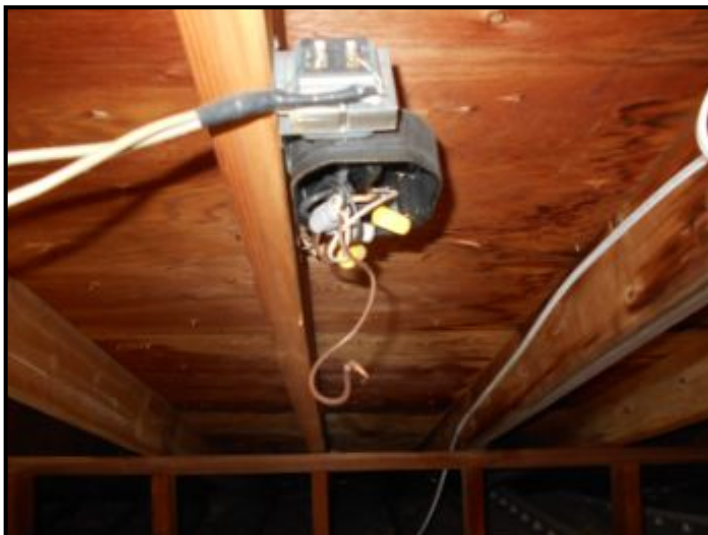
- There was an open electrical junction box located in the attic. This is an electrocution hazard. Recommend consulting a licensed/qualified contractor for repair.

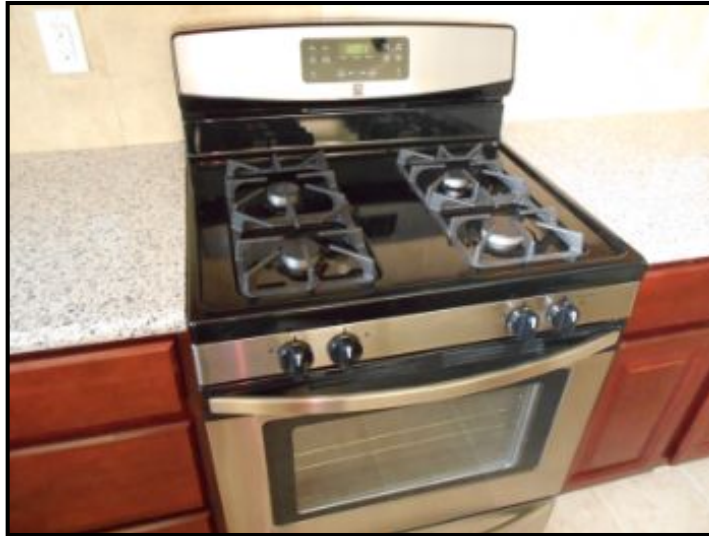
Unit is not level and wobbly . Recommend leveling prior to settlement to ensure proper operation.

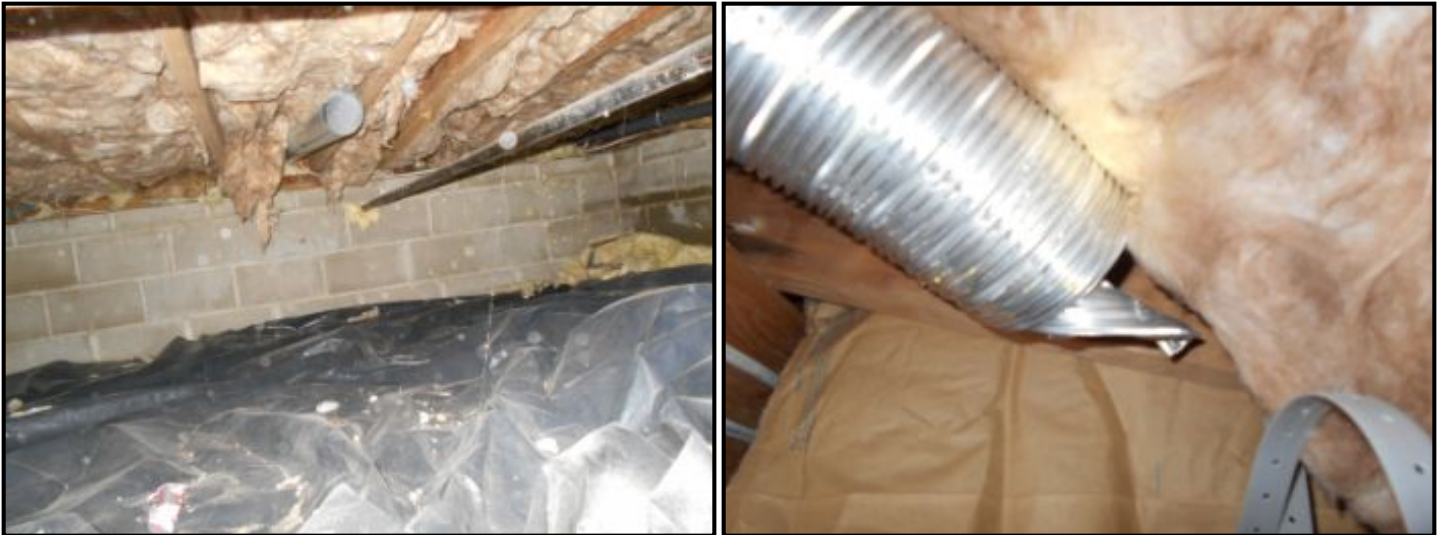
- The dryer vent terminates in the crawlspace. Recommend connecting the vent with the outside fitting already in place by a licensed/qualified contractor.

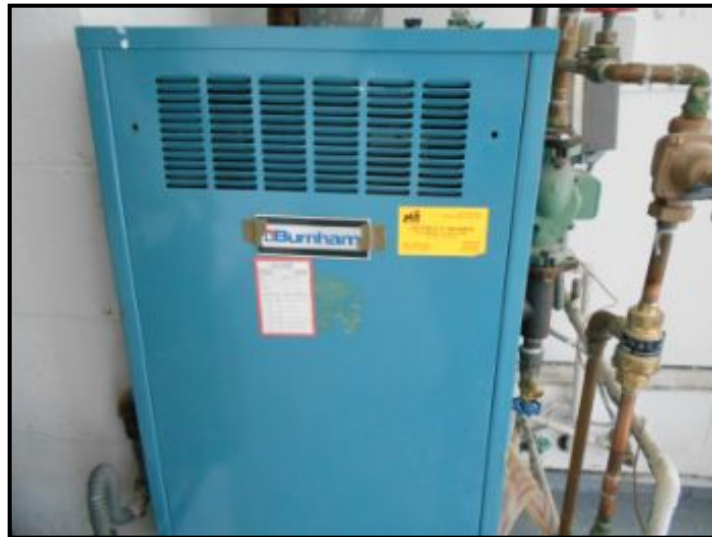
- The gas fired boiler is manufactured by Burnham and was made in 1986. The unit is approximately 29 years old. The boiler is at the end of its service life. Budgeting should be in place by the homeowner for a replacement.

- Garage installation of gas-fired appliances generally require the burner to be 18 inches above the floor level to ensure separation from flammable vapors. This is a serious safety concern. Recommend review by a licensed heating contractor for repair or replacement, as necessary, prior to close.

It is unknown the last service date of this unit. Recommend servicing by a licensed/qualified contractor prior to settlement.

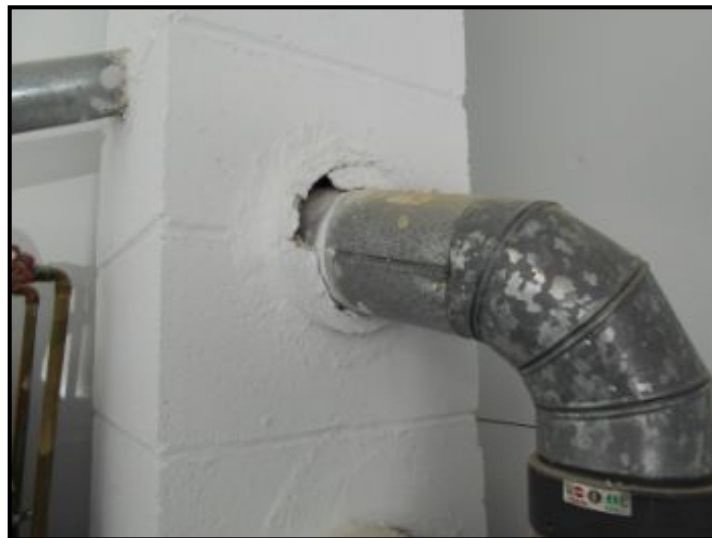
- ****VENTING MATERIALS****
- Metal single wall chimney vent pipe noted.
- ****VENTING OBSERVATIONS****
- Exhaust pipe located in the unit needs sealing at the chimney. This is to prevent any carbon monoxide from entering the living space. Recommend servicing by a licensed/qualified contractor.

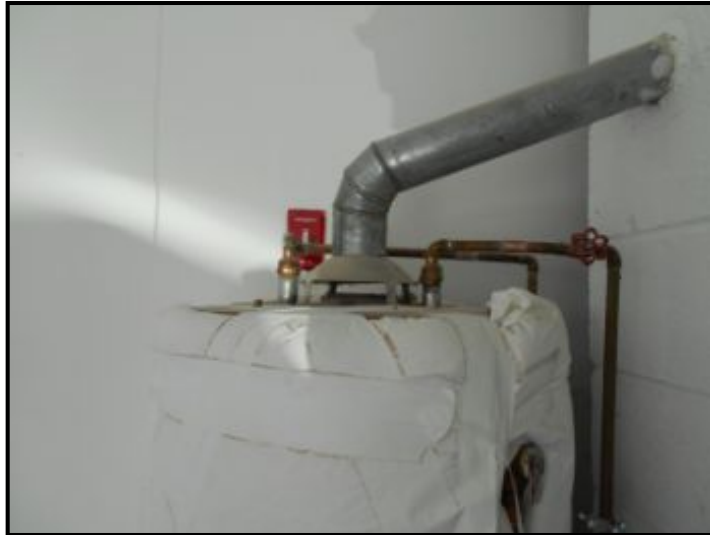
- It is unknown the age or make of the water heater. By its appearance it is at the end of its serviceable life. Budgeting should be in place by the homebuyer in the event of failure.

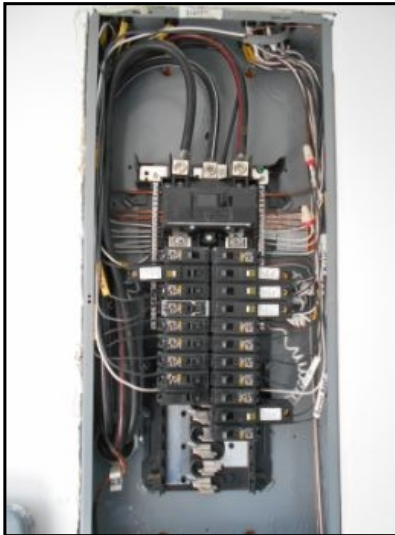
- No major system safety or function concerns noted at time of inspection at main panel box.
- Panel cover screw(s) missing.

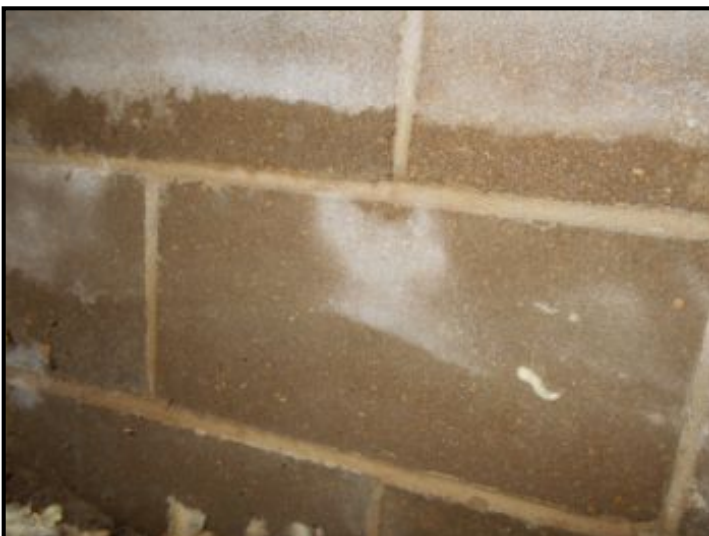
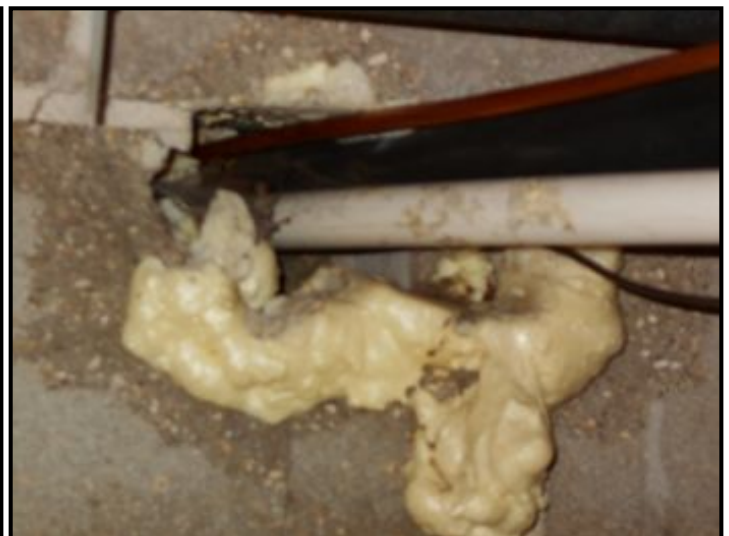
- Efflorescence observed; this is a mineral deposit left behind from exterior water infiltration.

- **IMPROVE:** Recommend sealing the pipes as the exit the crawlspace to the exterior. This is to prevent any insects/vermin to enter the dwelling.

IMPROVE: Recommend a basement specialist install a 6mil vapor barrier on the earthen floor to prevent moisture from entering the basement. In addition the walls should be insulated and ventilation increased to eliminate moisture.

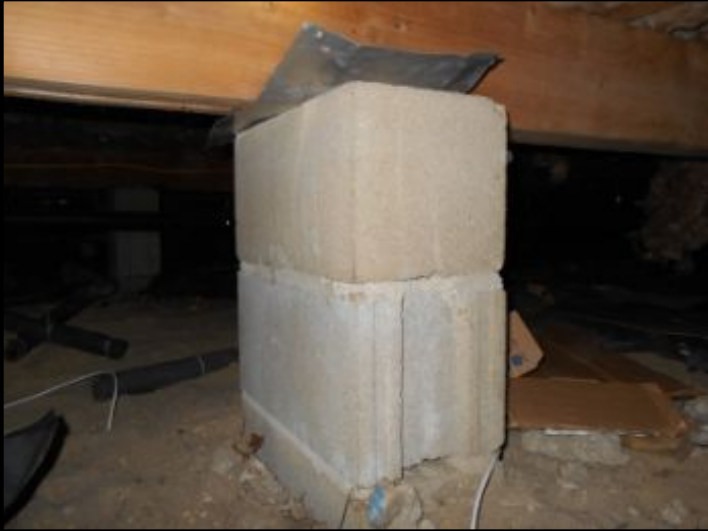
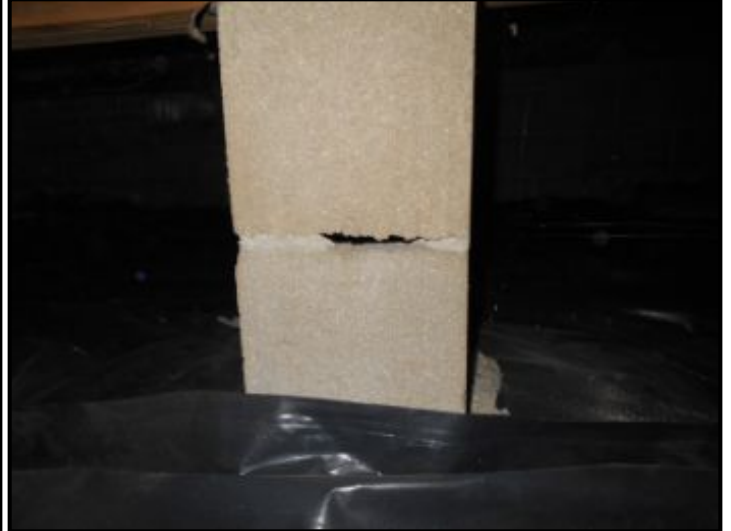
Several block piers were missing mortar in the joints. Recommend a licensed/qualified contractor make repairs to prevent collapse of the piers thus the wood beams.

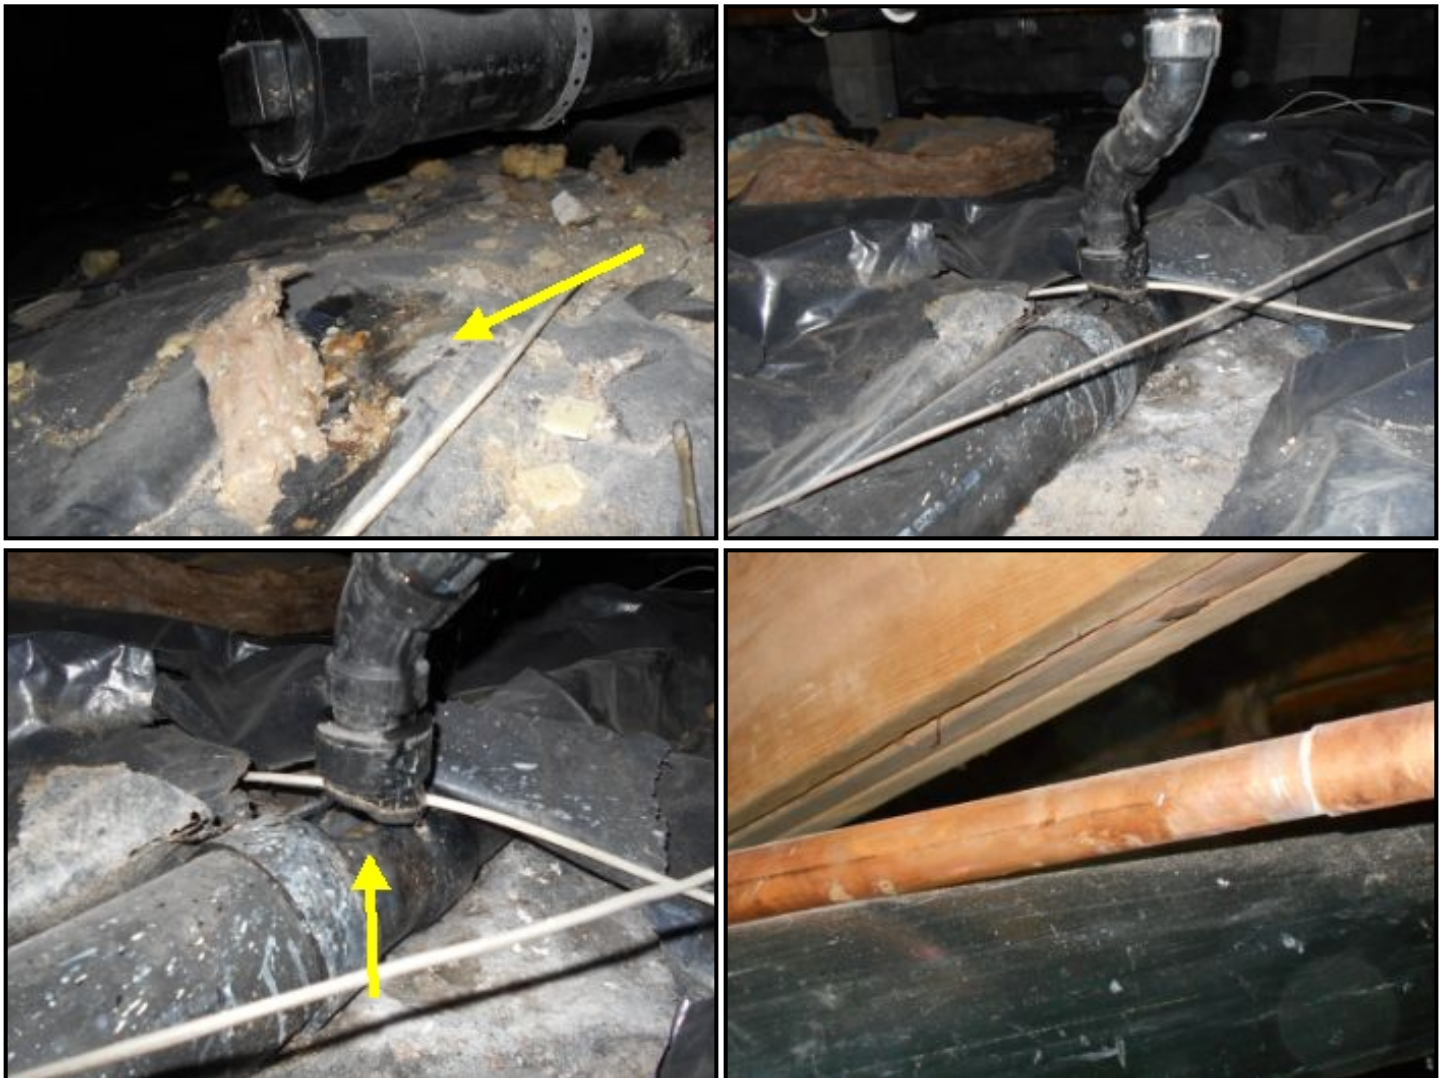
Materials: ****WASTE**** • Drain lines appear to lack proper support, recommend adding support hangers. In addition, the drain line is sitting on the earthen floor. Recommend a licensed/qualified plumber hang waste pipe as to industry standards. • The copper water supply line has missing/cracked insulation. Recommend installing insulation on all piping in the crawlspace to prevent freezing in the winter.

- ABS
- Copper
- The waste line for the kitchen sink/dishwasher was snapped at the fitting and water was leaking into the crawlspace. Recommend a licensed/qualified contractor repair immediately prior to closing.
- The waste line for the bathroom located in the crawlspace is leaking at the cleanout. Recommend servicing by a licensed/qualified contractor prior to settlement.

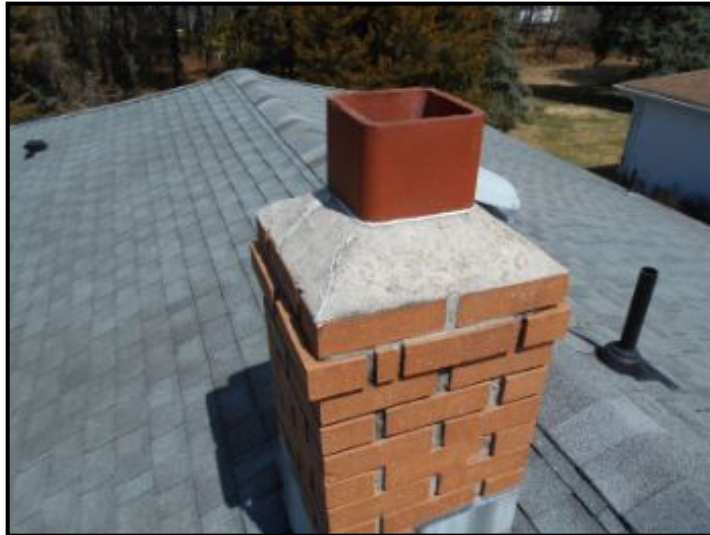
- **IMPROVE:** Installing a rain cap on the chimney to prevent any moisture/vermin from entering the structure. This can be done by a licensed/qualified contractor.
